Conservation Area Appraisal

Beckington

August 2010

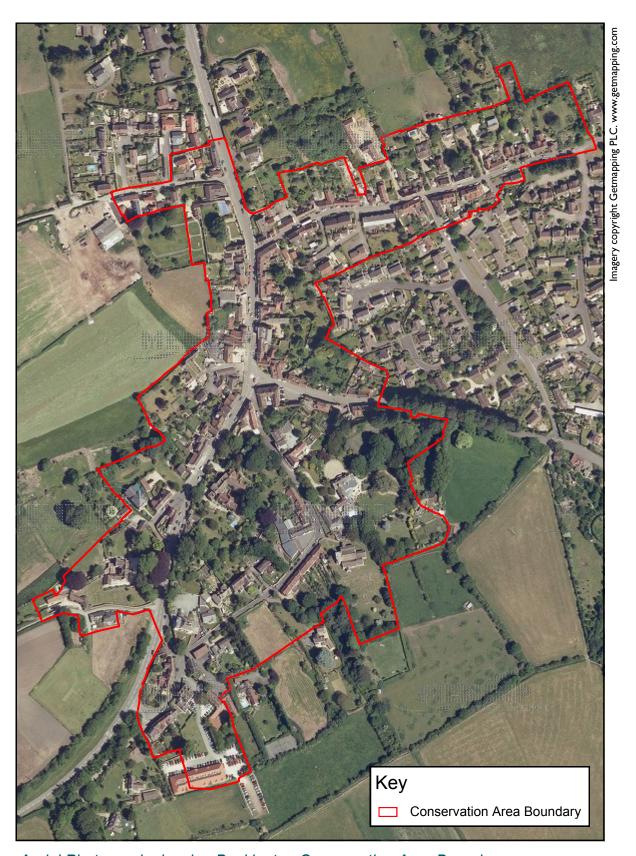
Aerial Photograph showing Beckington Conservation Area Boundary
